Santa Clara Creek Restoration

Scott Cameron
Santa Clara Univeristy

Senior Design Project Report

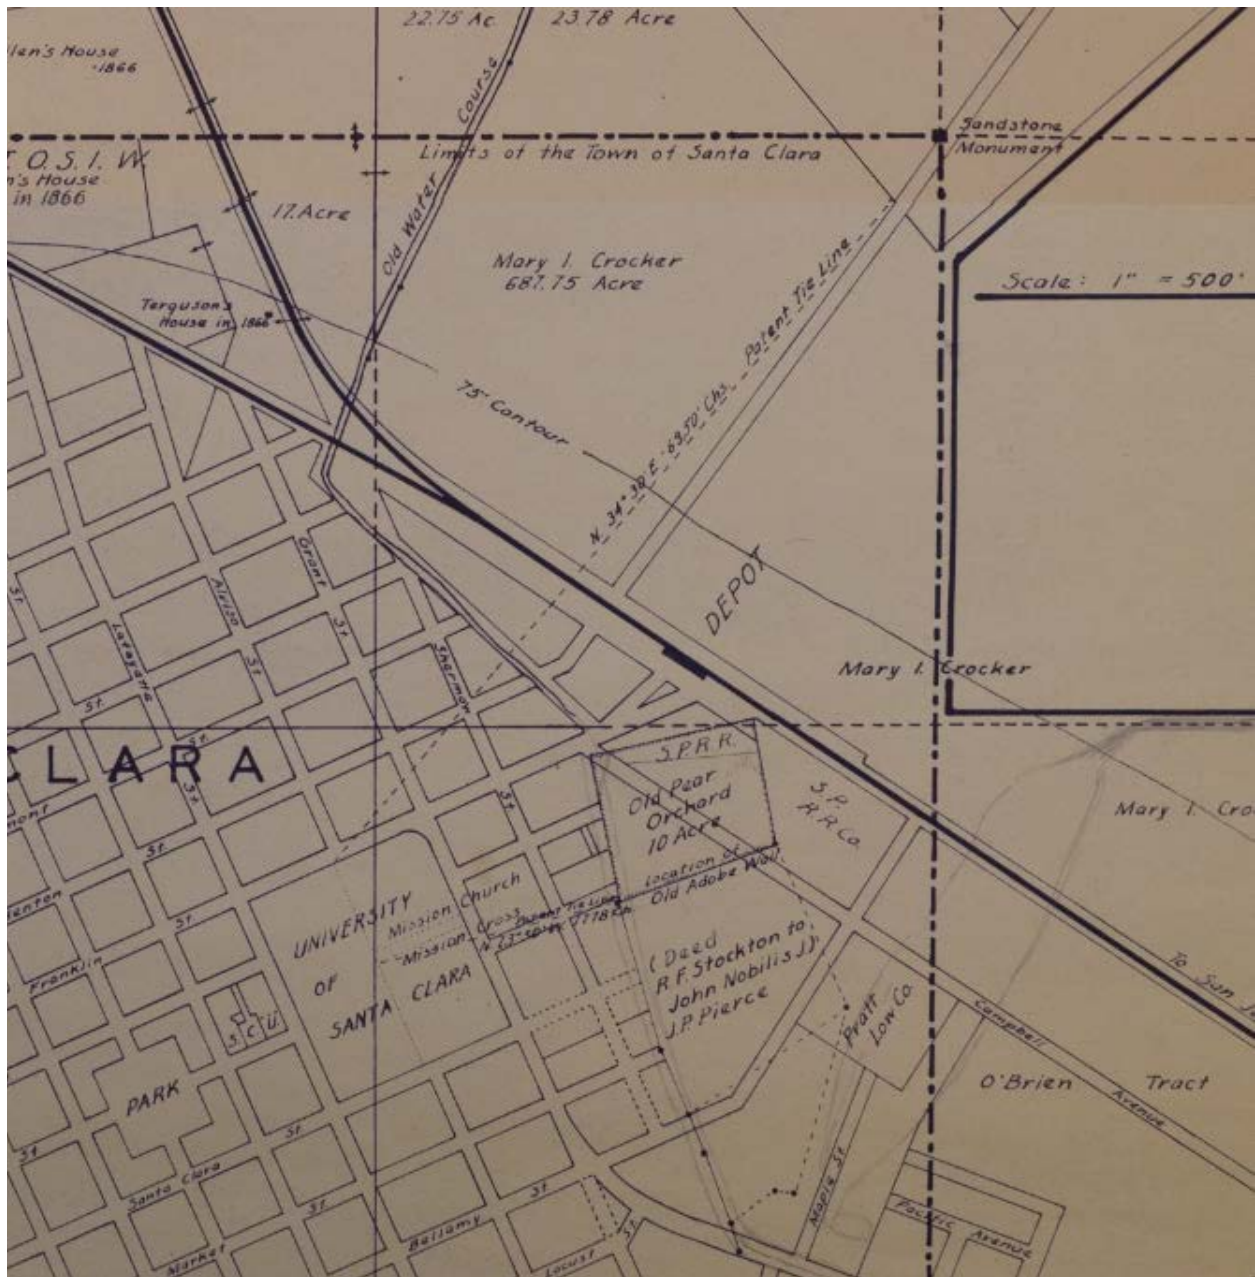
Figure 2 - Map of the city of Santa Clara Circa 1900. The perimeter of the University and the Old Pear Orchard were used to locate the stream in Figure 1 in current space. [Santa Clara University records]

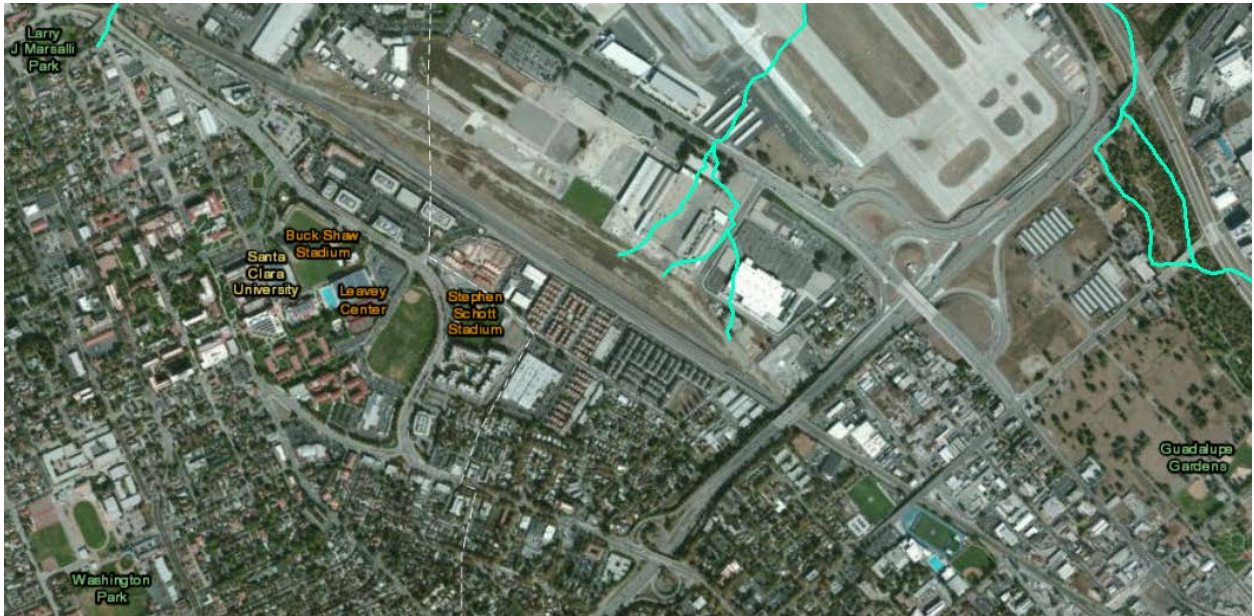
Figure 5 - Map of present city of Santa Clara overlaid with previously known historical channels. [Map generated in Arc GIS 10.1, data courtesy of SFEI 2011, provided by ESRI]

In recent history, the entire Santa Clara Valley has been subject to heavy flooding due to the rapid buildup of infrastructure in San Jose nearby. We have a sprawling metropolis built atop wetlands, but the only remaining natural surface water in the vicinity is the Guadalupe River which is, and has historically been about 1.5 – 2 miles from Santa Clara University. The natural ponds as well as all tributaries in Figure 1 are completely gone. Figure 5 below shows the main historical tributaries as they can best be modeled excluding the stream in question. These channels are unnamed, and run as close as ¼ mile to the campus, branching a little over a mile from the main river. When shown over Figure 1, these

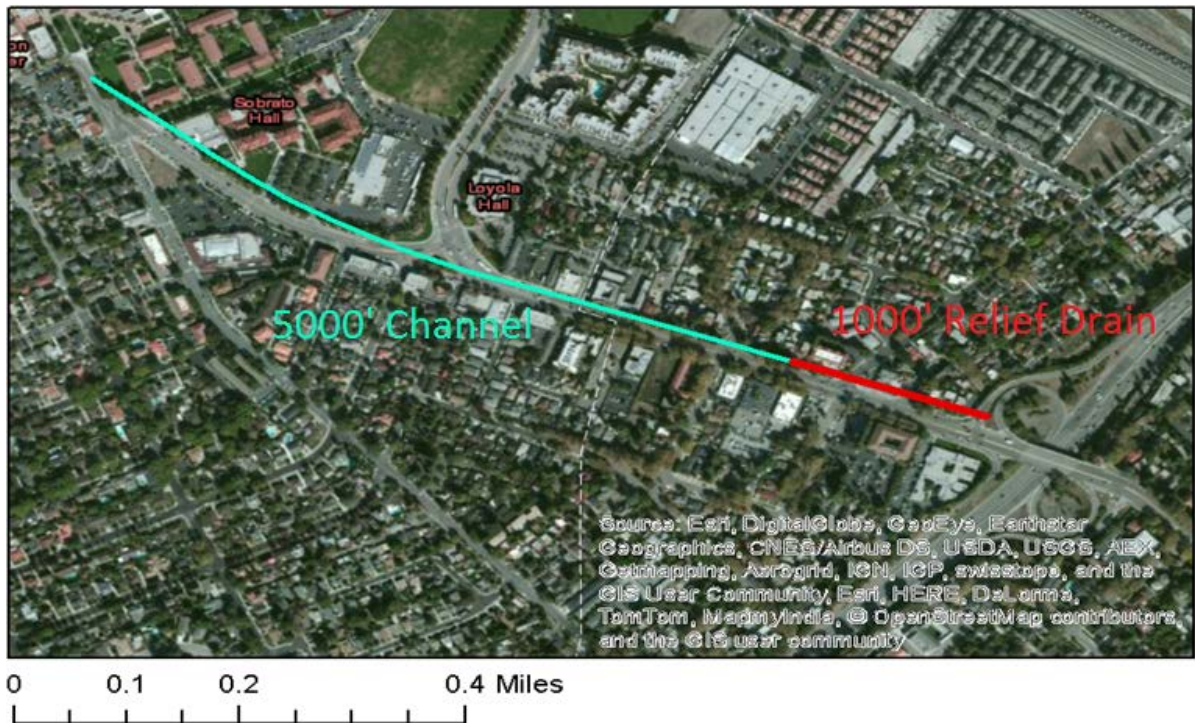
Figure 8 - Arcmap aerial plan view of the channel with connecting relief drain.

Figure 8 is an aerial profile of the channel and shows the relief drain connected to the channel.

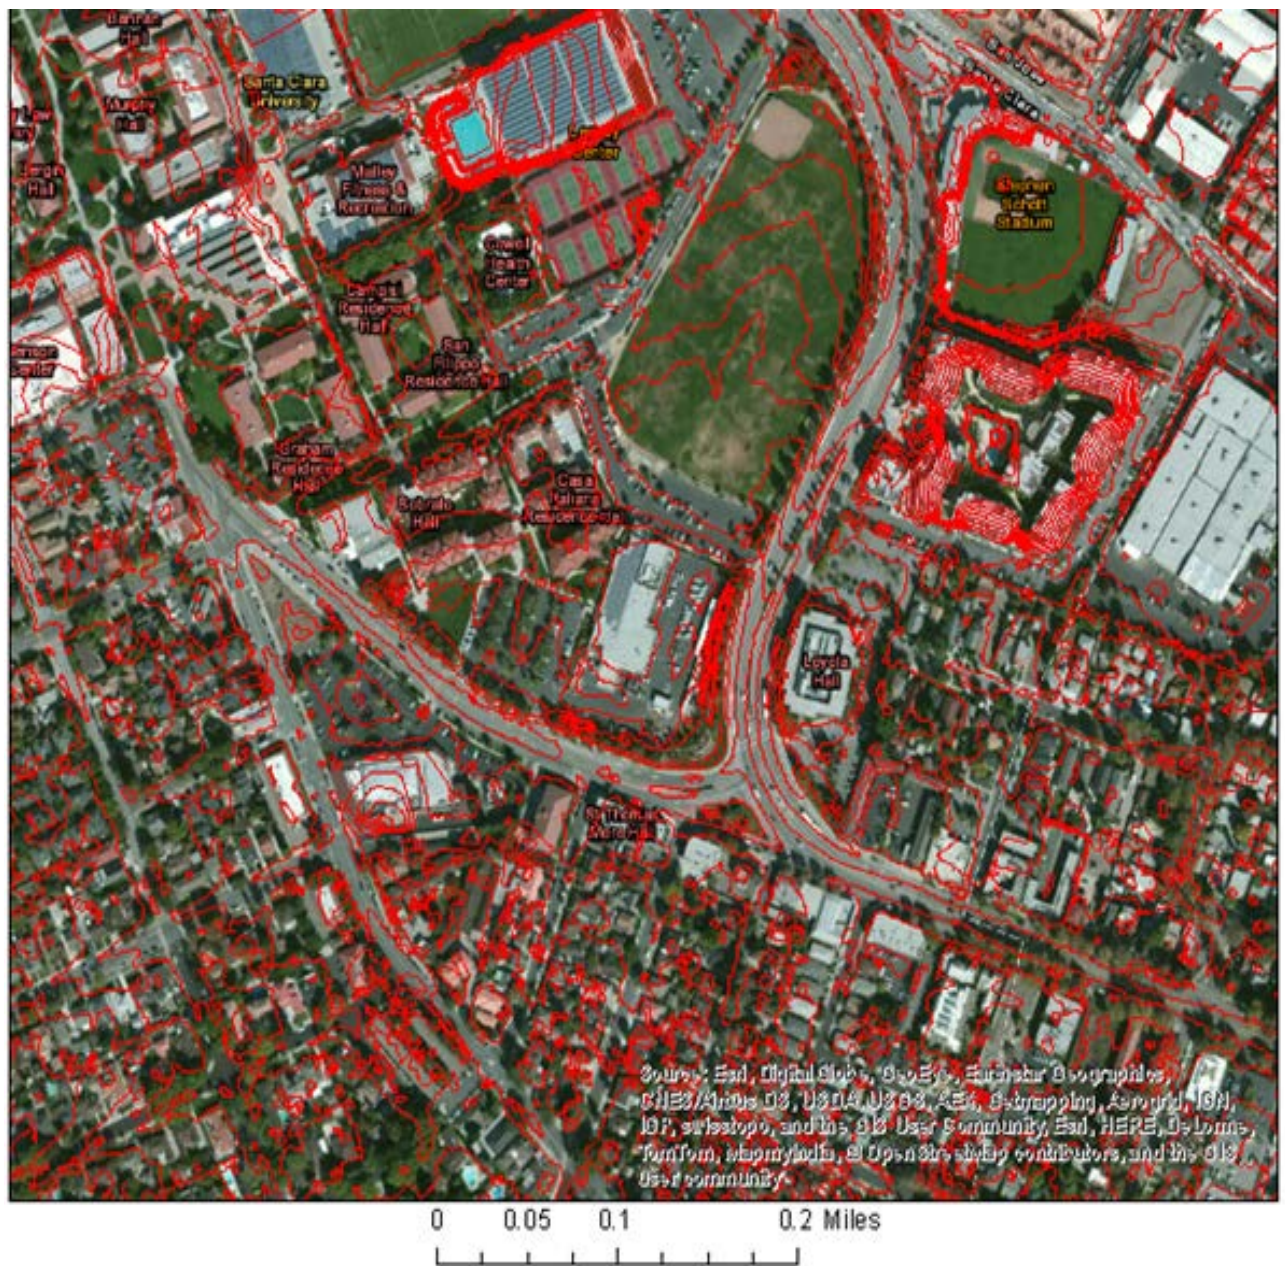
Figure 14 – Lidar Data contour map of the City of Santa Clara [Courtesy of the SCVWD]

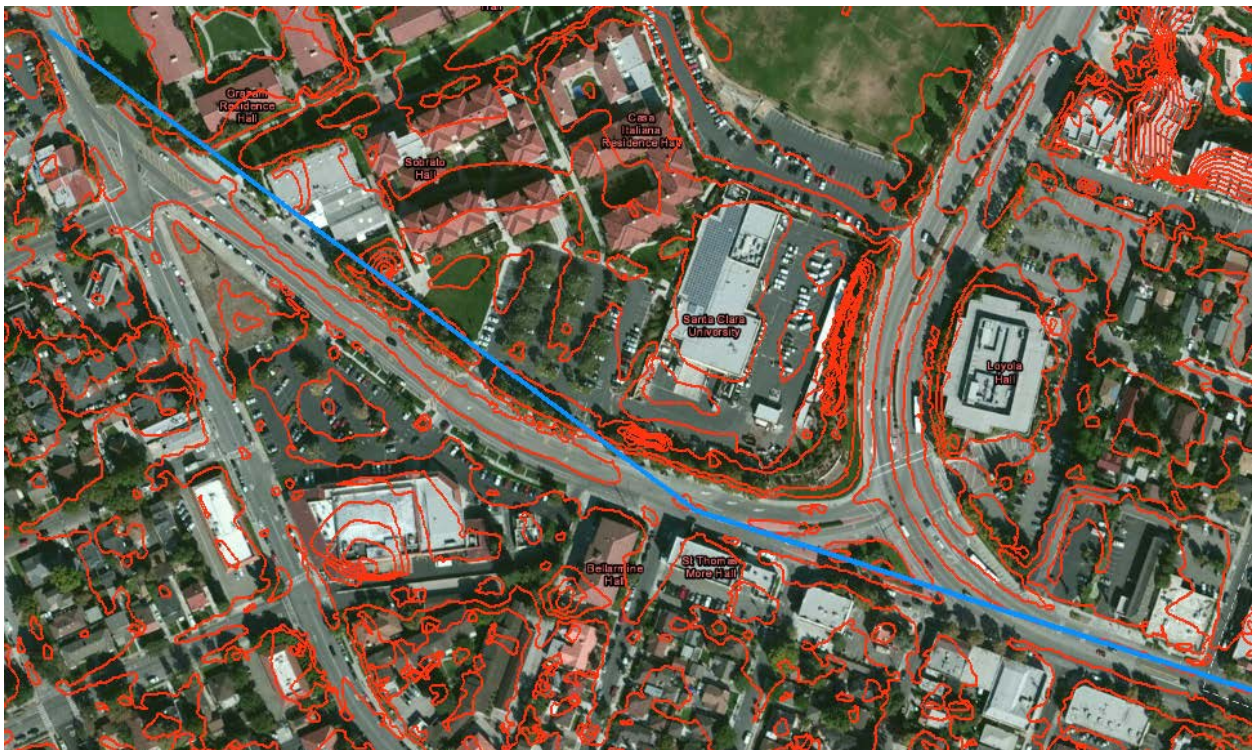
Figure B2 - Raw imported Lidar data in ArcGIS.

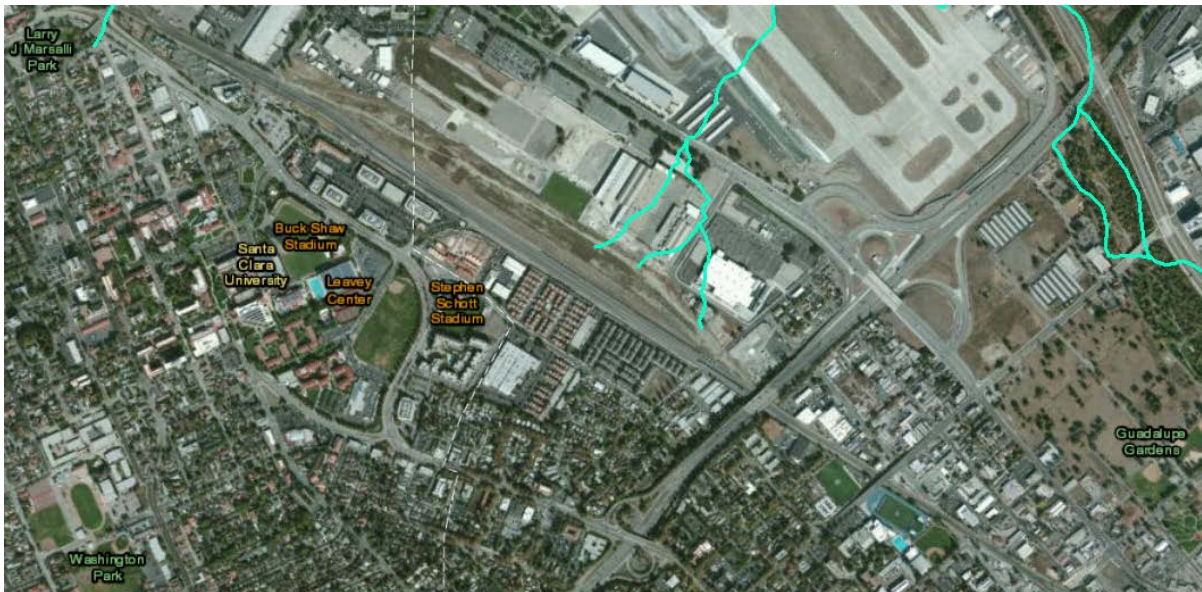
Figure E3 - Map of present city of Santa Clara overlaid with previously known historical tributaries. [Map generated in Arc GIS 10.1, data courtesy of SFEI 2011, provided by ESRI]

One design considered was the restoration of the center channel that is modeled in the following image. This channel also appear in Figure 1 from the main portion of the report. This channel was considered because it is better documented than the channel that was eventually chosen and it resided in an area that, now, would make restoration far simpler. It was ultimately decided against in the final scope of work as the intention of the project was to restore a channel that was as close to the University as possible, and this channel resided one quarter mile from the University at its closest point.
